PWS ID#: 11101233
Saddle Ridge Estates-OC
Columbia County

Subject: Sanitary Survey Report

Sanitary Survey Checklist for SADDLE RIDGE ESTATES/11101233, Survey Date: 07/18/2023

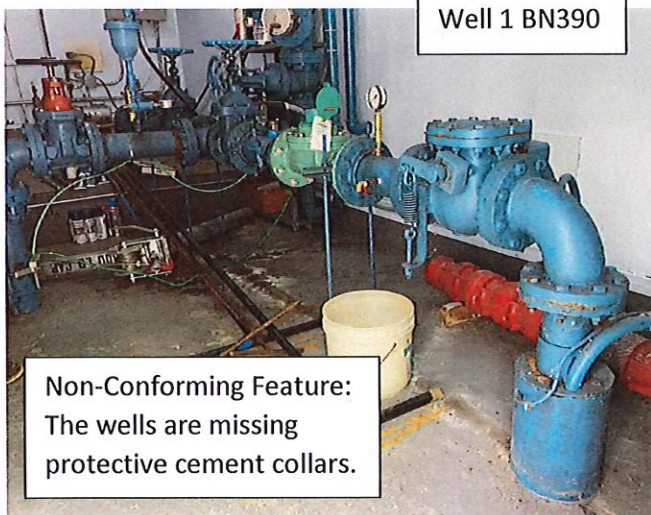
Well 1 BN390

Non-Conforming Feature:
The wells are missing protective cement collars.

Discussion of Non-conforming Features: Please correct when major well work is completed in the future.

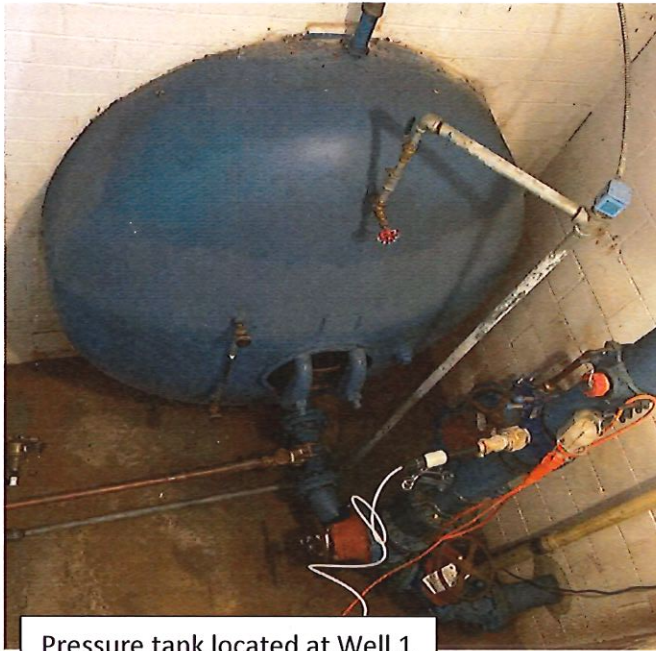
Pressure tank located at Well 1

- 1) The electrical conduit on Well 1 is loose. Please continue to monitor this and inspect or repair when well work is completed in the future.
- 2) Open, inspect, and clean the interior of the pressure tank.

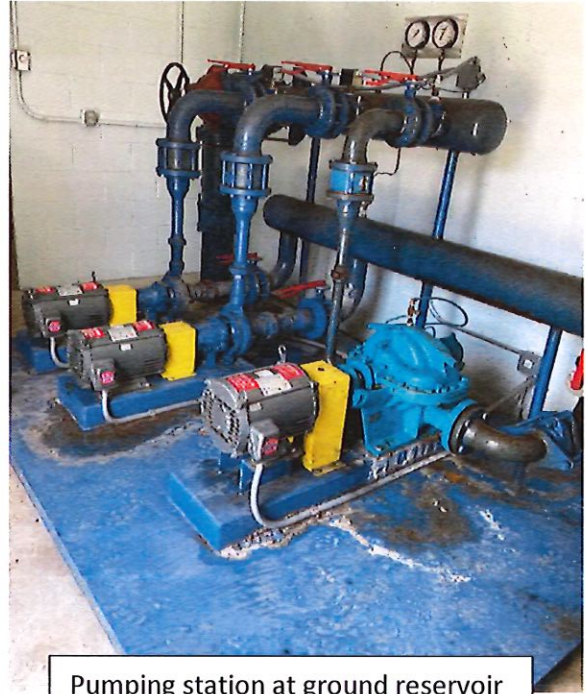
Pumping station at ground reservoir

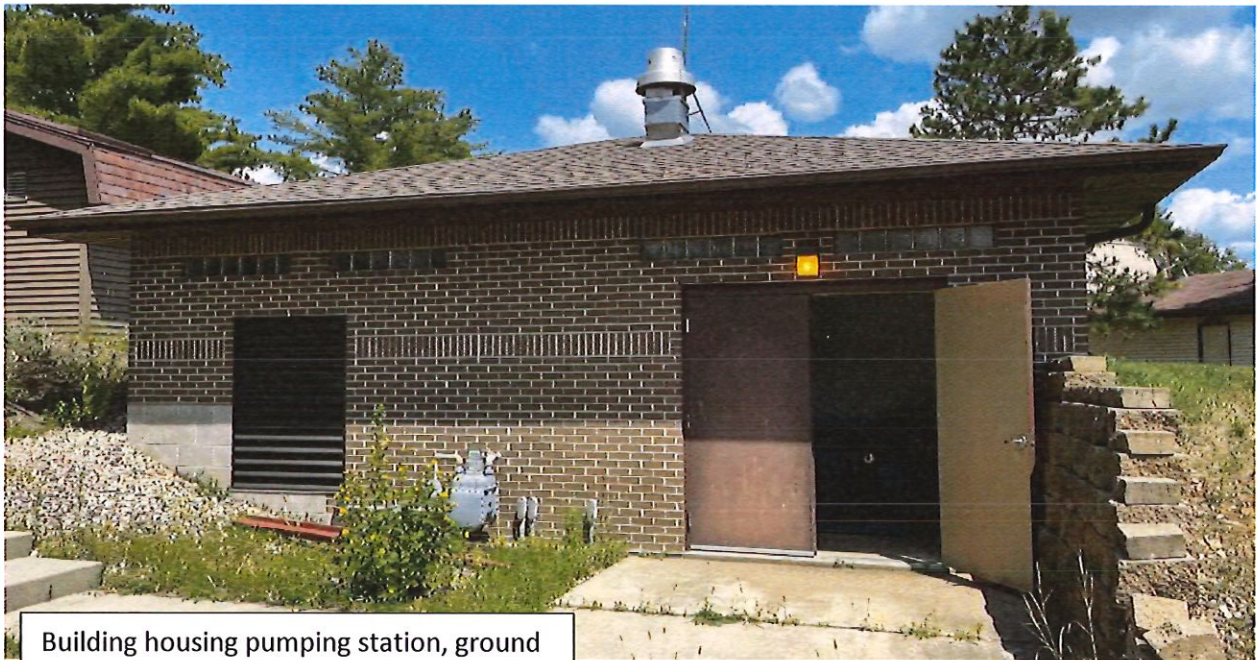
Building housing pumping station, ground reservoir, and emergency generator
