PWS ID#: 11101233
Saddle Ridge Estates-OC
Columbia County

Subject: Sanitary Survey Report

Sanitary Survey Checklist for SADDLE RIDGE ESTATES/11101233, Survey Date: 07/18/2023

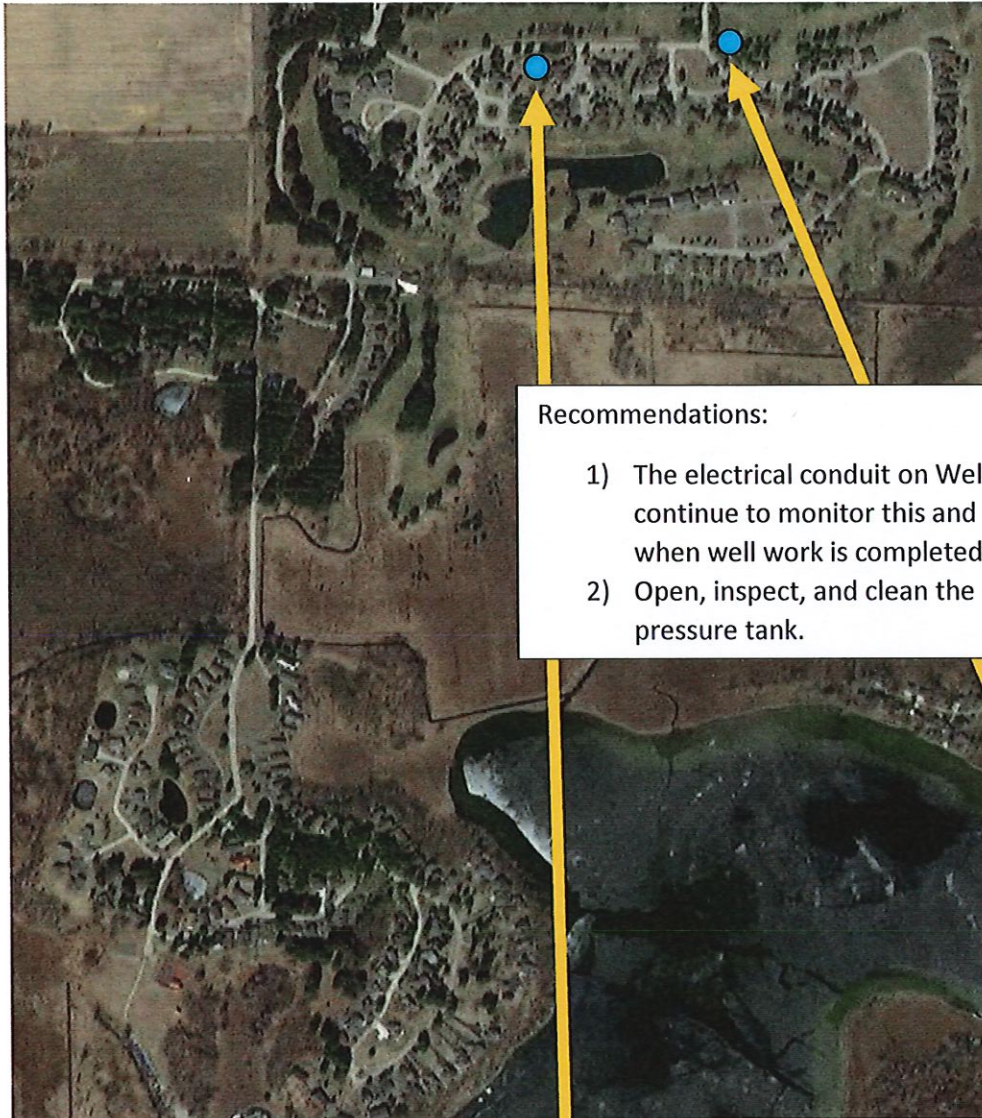
E.	Is the condition of the pump(s) satisfactory? (810.03)	Y	
F.	Does the pumping system(s) use only approved lubricants? (811.31 (2))	Y	
G.	Are pumping controls adequate and in good working condition?	Y	Recommendation- The electrical conduit on Well 1 is loose. Please continue to monitor this and inspect or repair when well work is completed in the future.

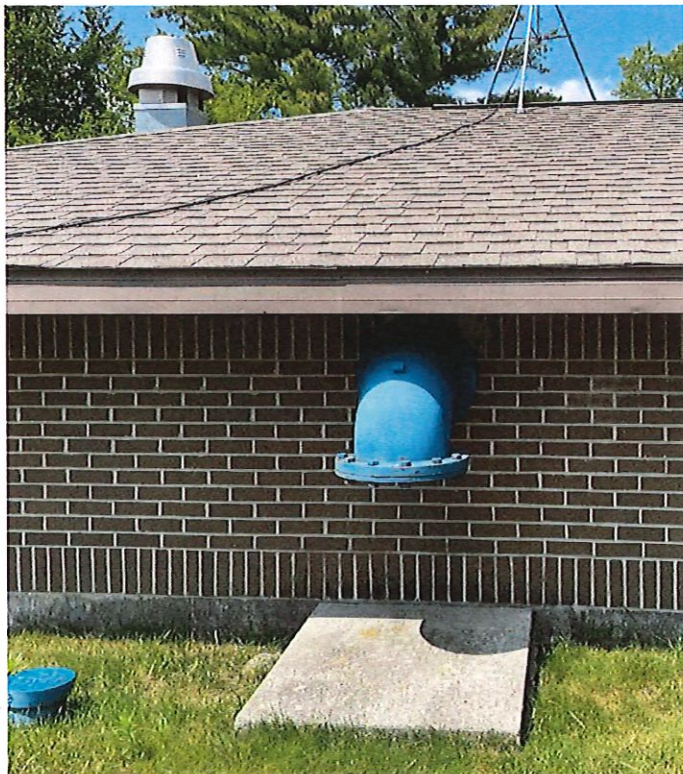
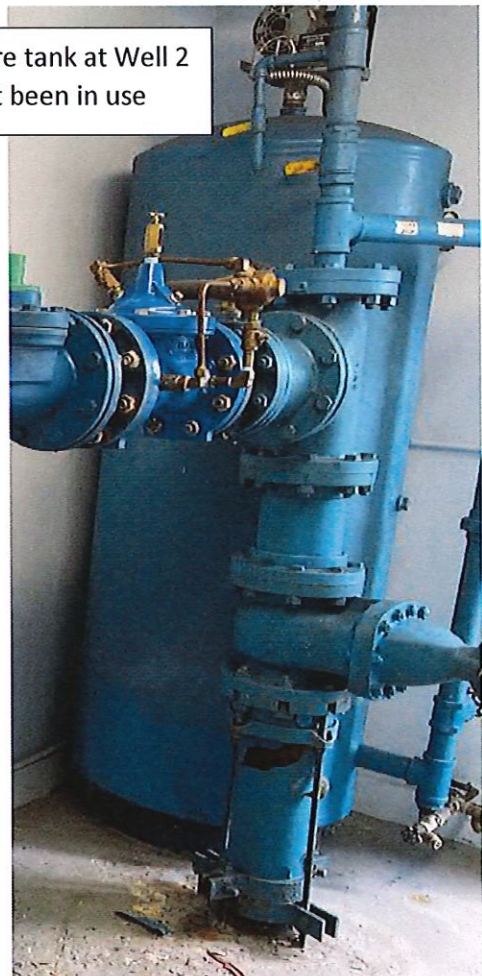
Pressure tank at Well 2
has not been in use

- 1) The electrical conduit on Well 1 is loose. Please continue to monitor this and inspect or repair when well work is completed in the future.
- 2) Open, inspect, and clean the interior of the pressure tank.
